## BC PLACE STADIUM

# ROOF DEFLATION INCIDENT INVESTIGATION ENGINEER'S REPORT

12 October 2007

By: **Geiger Engineers**  
Bellingham, WA  
**Kris P. Hamilton P.E.**  
David M. Campbell P.Eng.

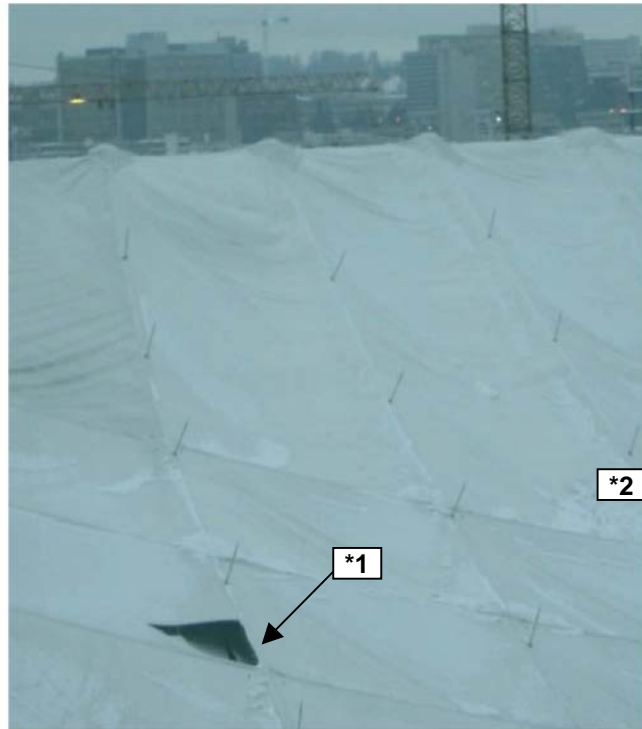
**Figure A1-1:** Looking across deflated roof, Jan 5, 2007

- \*1 – Secondary tear caused by motions of roof due to windstorm the night after the deflation.
- \*2 – Note the accumulated snow along bottom edge of each panel where it hits cable.

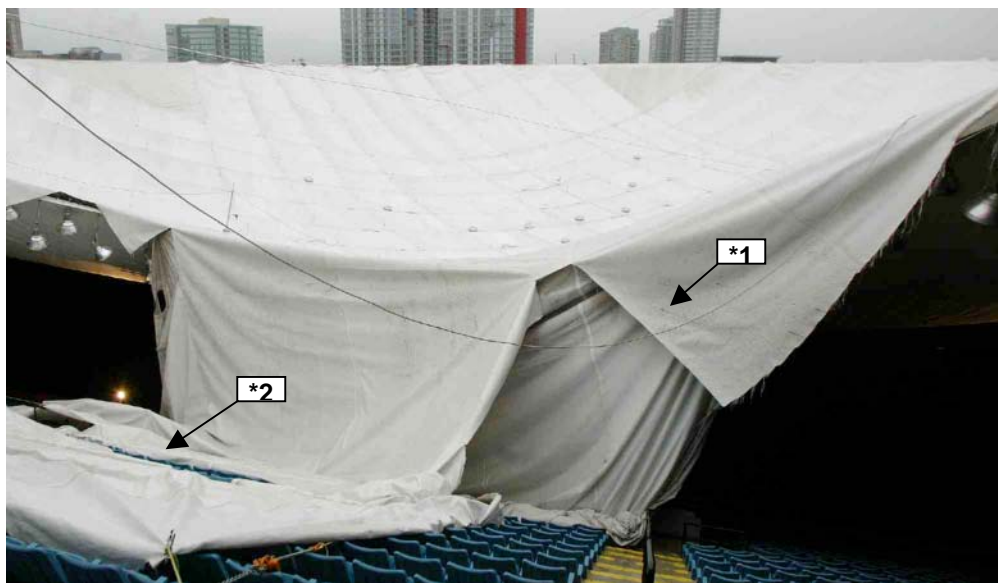
**Figure A1-2:** Damaged Triangle Panel, Jan 6, 2007.

4. We identified several areas of fabric near the edge of the panel that were possibly weakened, and one area near the center of the panel edge attached to the ring beam that was clearly deteriorated. This locally deteriorated area was torn in two directions; see Figure E1. This appears to be the point of initiation of the tear. There was also a large tear in the main panel parallel to the ring beam edge, perhaps 20 meters from the ring beam. This tear was not connected to any other part of the tear at the ring beam, and had not been reported to be part of the original failure scenario. It is likely that this tear occurred subsequent to the deflation from prolonged buffeting of the triangle in the windstorm of the 5<sup>th</sup> prior to our arrival the morning of the 6<sup>th</sup>. See Figure A1-2, note \*2 and Figure E1.

- \*1 – Fabric delaminated along existing factory seam.
- \*2 – Panel partially separated here due to violent motions of panel during deflation and the high winds

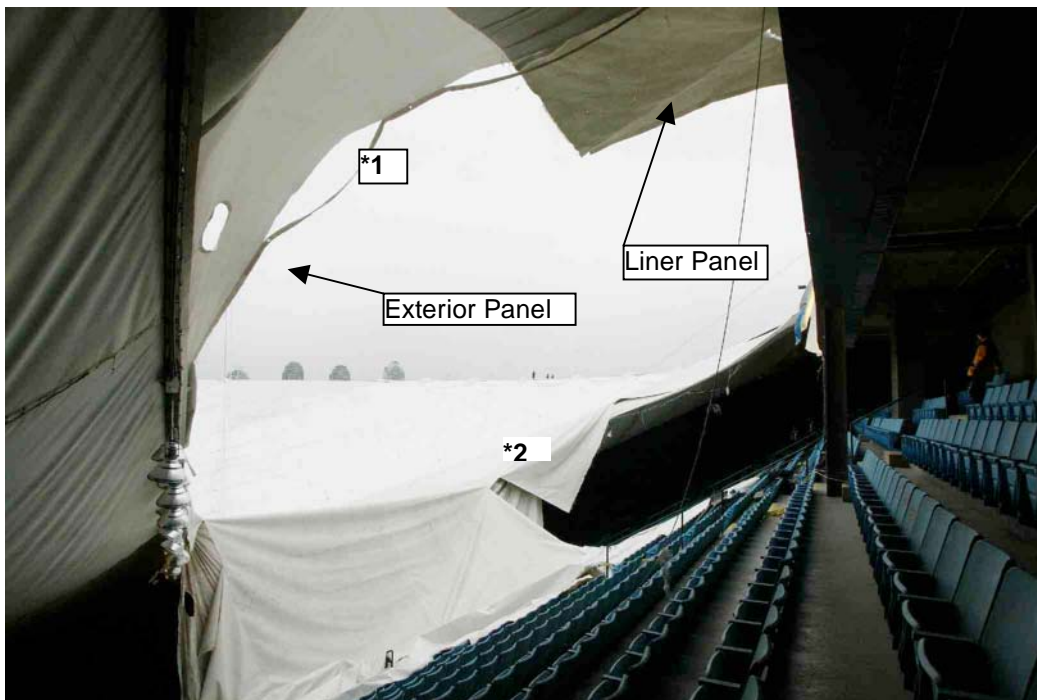
Figure A2-2: Damaged Panel View from Inside Looking East

\*1 – Segment of double fabric at longitudinal seam.

\*2 – Transverse tear across the fabric, away from seam because of double thickness and positive adhesion by heat sealing, the seam itself represents a stiffer and stronger load path. Under the shaking undergone by the panel it is reasonable to have such a separation.

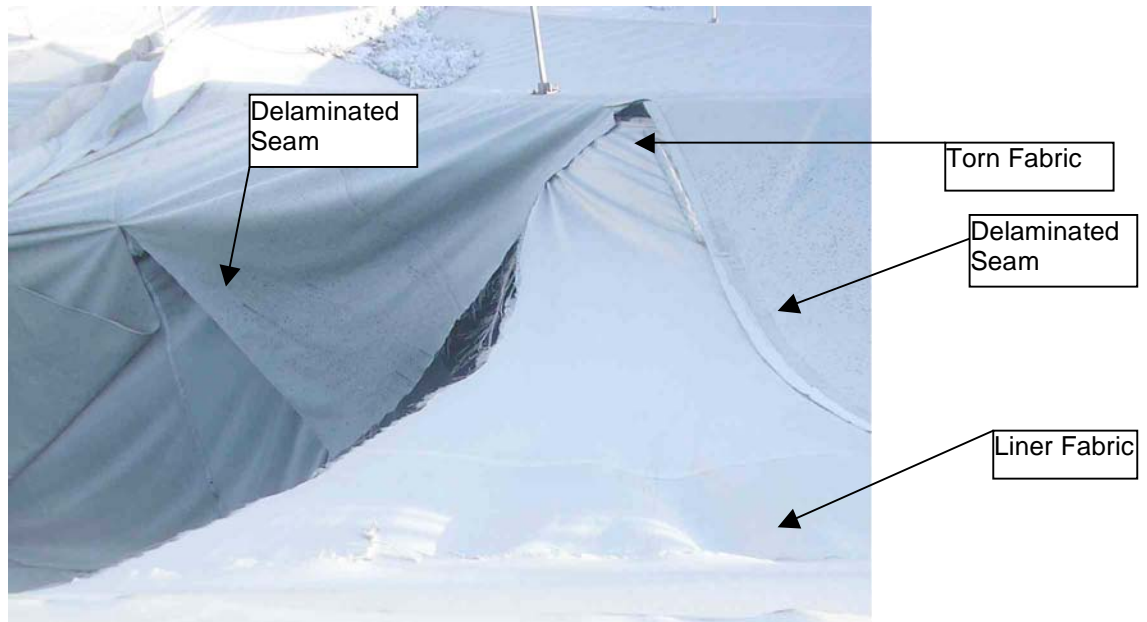
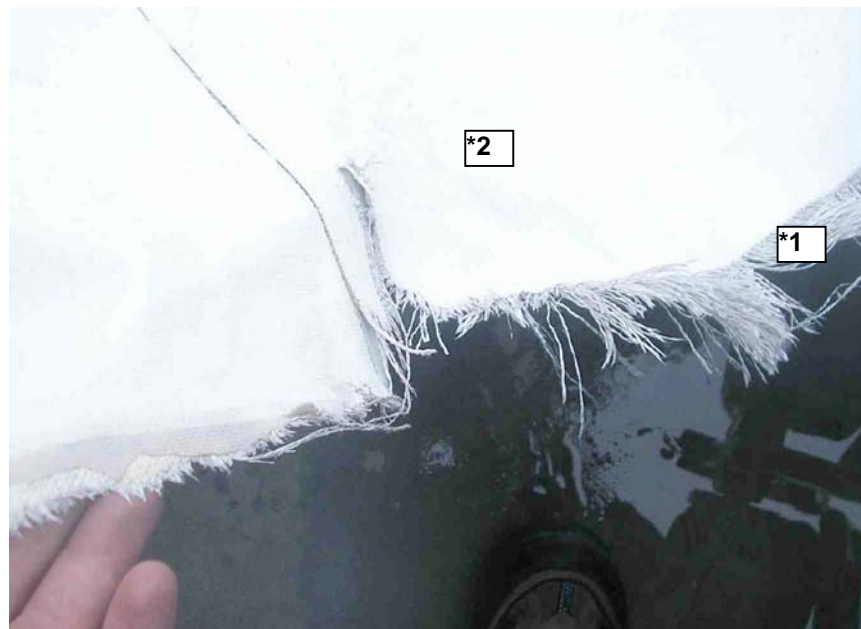
Figure A3-2

- \*1 – Torn fabric near ring beam. The long and clean fibers are characteristic of tears due to tension failure on undamaged fabric.
- \*2 – This tear has begun to progress up the center of a heat welded seam, which due to doubled fabric, is an unusual circumstance. The shorter, cleaner fibers visible in the tear are commonly associated with propagation due to tearing.

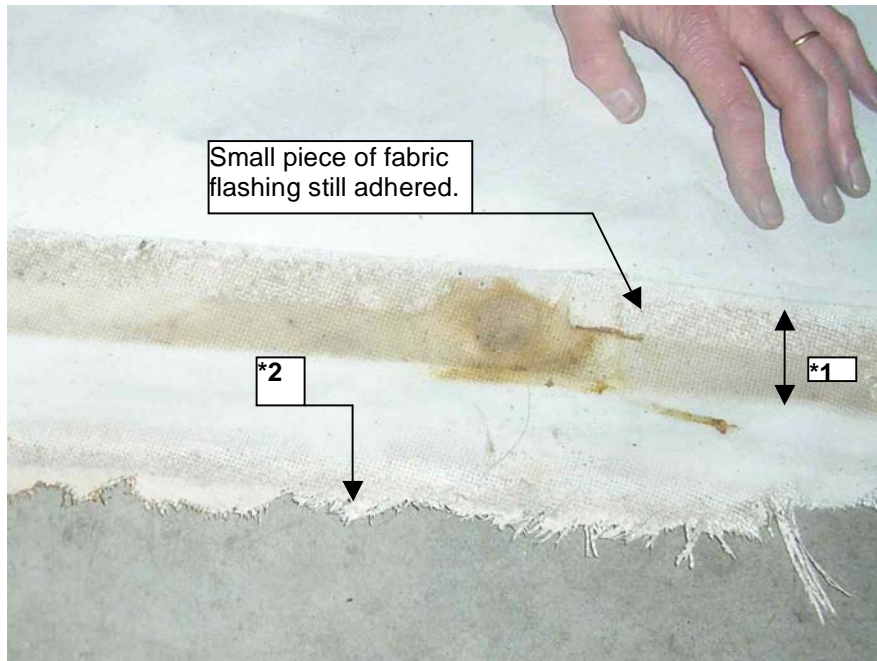
**Figure A4-1**

\*1 – Discolored area at attachment of flashing fabric to main fabric. Usually a darker color at a seam indicates higher temperatures used in making the seam.

\*2 – Light discoloration is at the upper edge of the heat seal at the roped edge. Random edge indicates irregular degrees of heat seal adhesion.

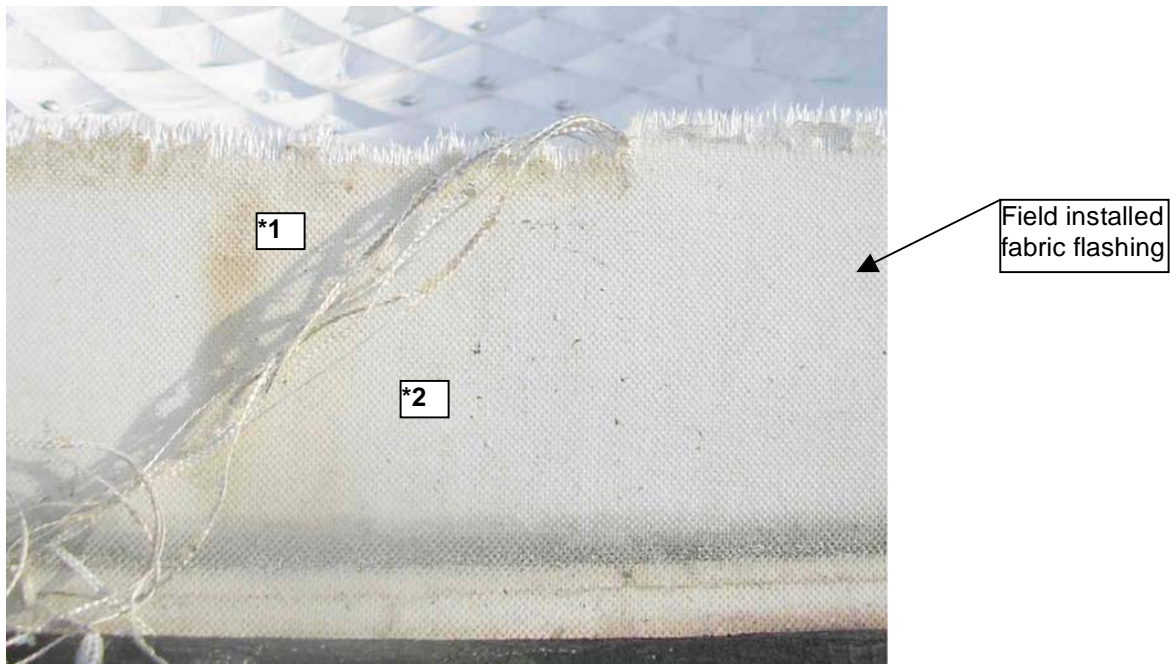
**Figure A4-2**

\*1 – Heat seal location from field installed fabric flashing. The short and clean fibers indicate tearing along the edge of seam.

\*2 – Long, loose yarns in these are indicative of tearing failure fill direction.

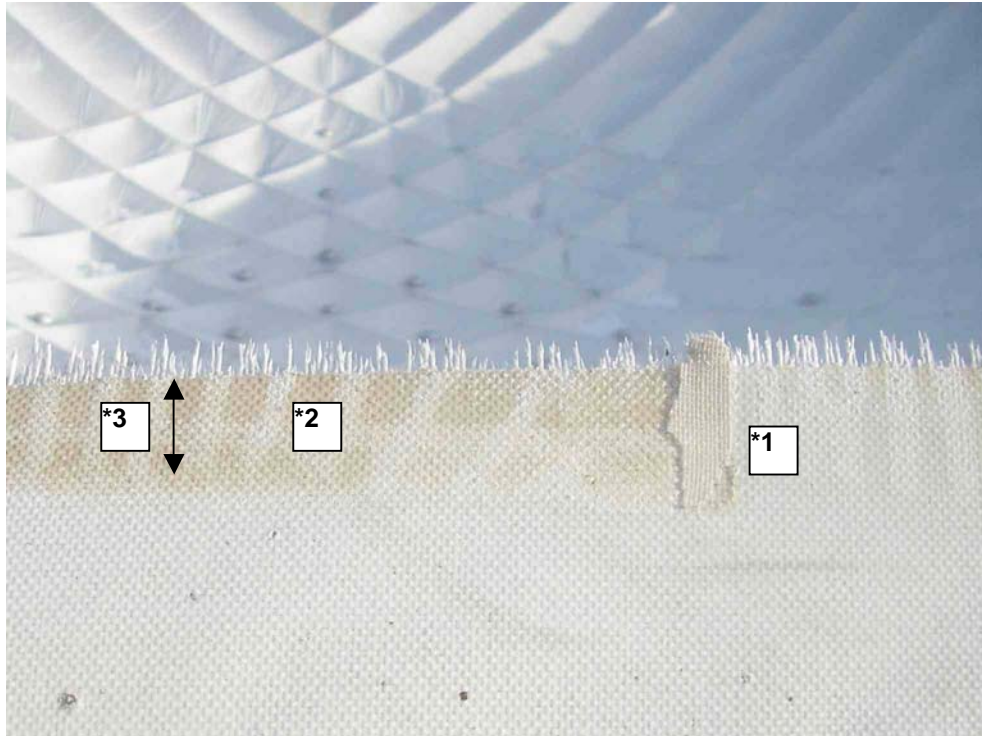
**Figure A5-1**

- \*1 – Small segment of the flashing fabric still attached. This lines up with a seam in the fabric flashing.
- \*2 – Short clean fibers indicate a tearing failure.
- \*3 – Field heat seal at flashing fabric.

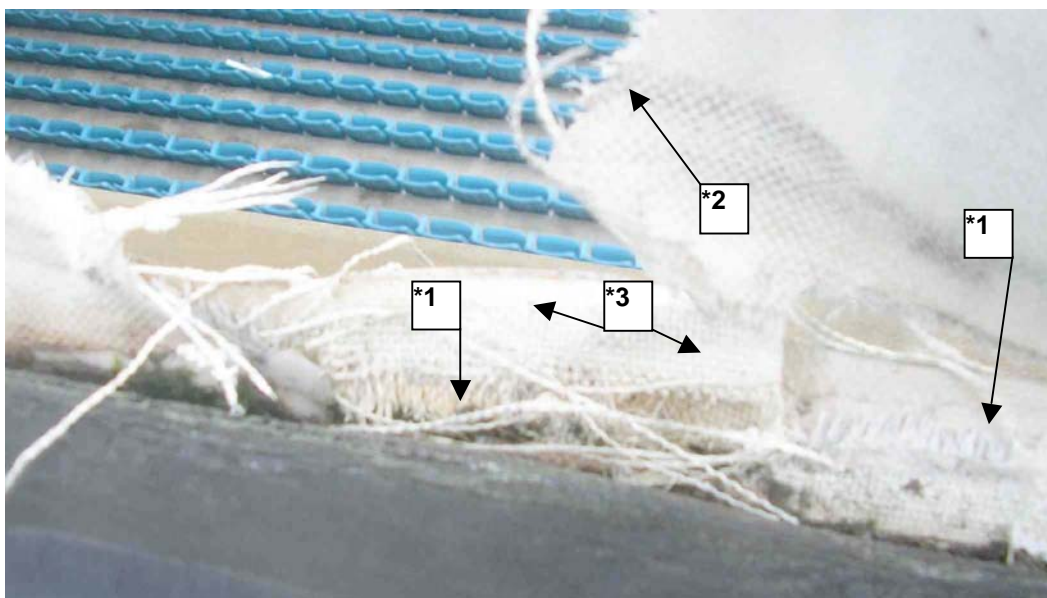
**Figure A5-2: Along ring beam**

- \*1 – Small segment of the flashing fabric still attached. This lines up with a seam in the fabric flashing.
- \*2 – Short clean fibers indicate a tearing failure.
- \*3 – Liner fabric

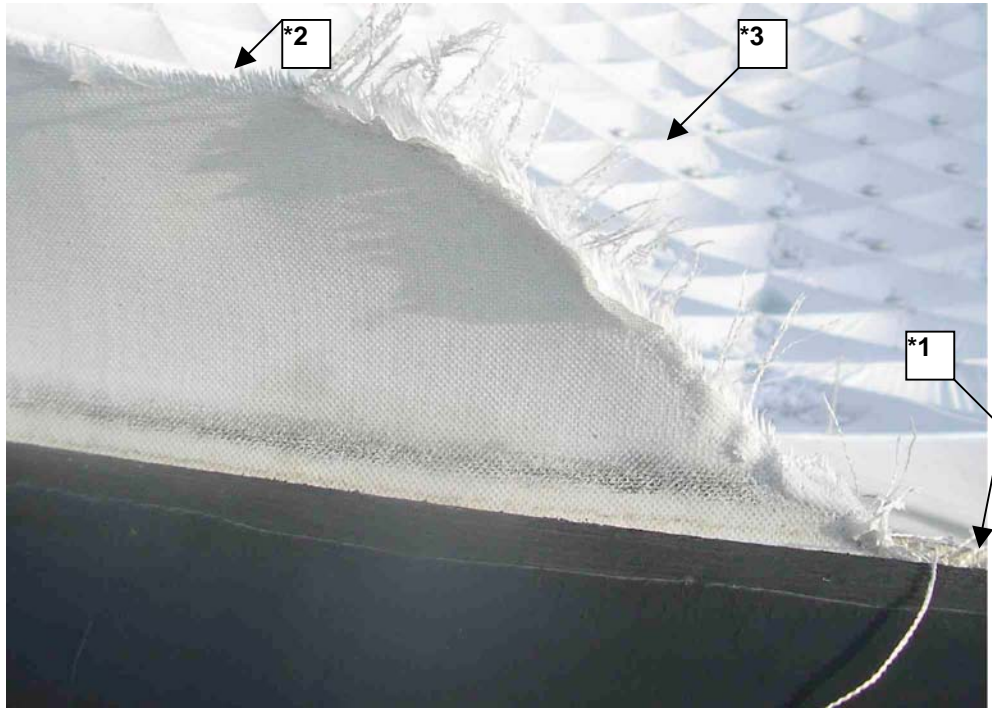
**Figure A6-1:** Roof at ring beam edge at postulated tear initiation location

- \*1 – Note short discolored fibers at edge of ring beam clamp.
- \*2 – Short discolored yarns at break, near edge of field weld at fabric flashing.
- \*3 – Longer fill yarns.

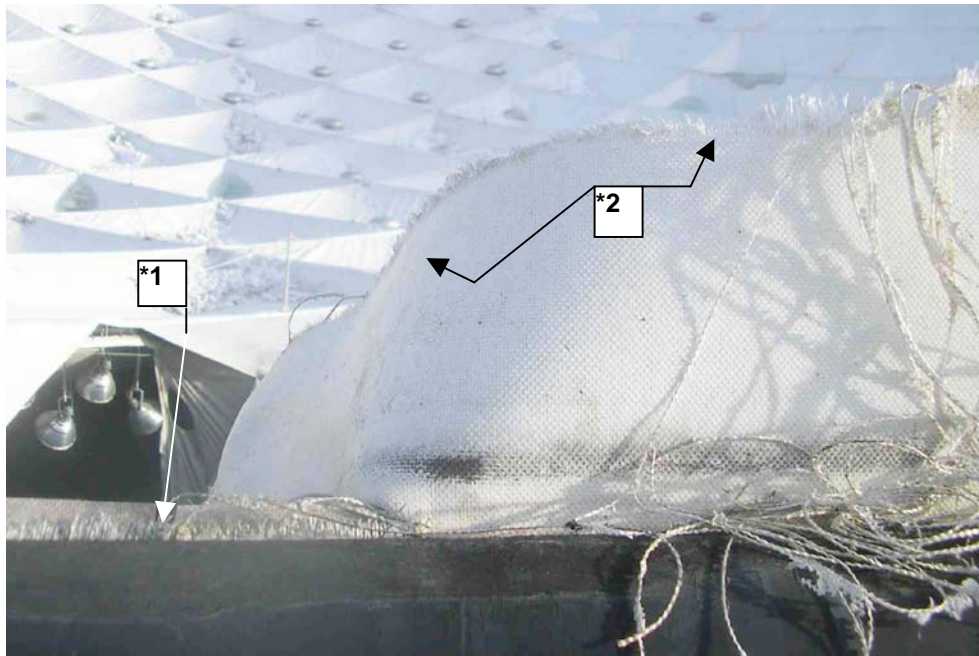
**Figure A6-2:** Roof at ring beam edge at postulated tear initiation location

- \*1 – Note short discolored fibers at edge of ring beam clamp.
- \*2 – Short discolored yarns at break, near edge of field weld at fabric flashing.

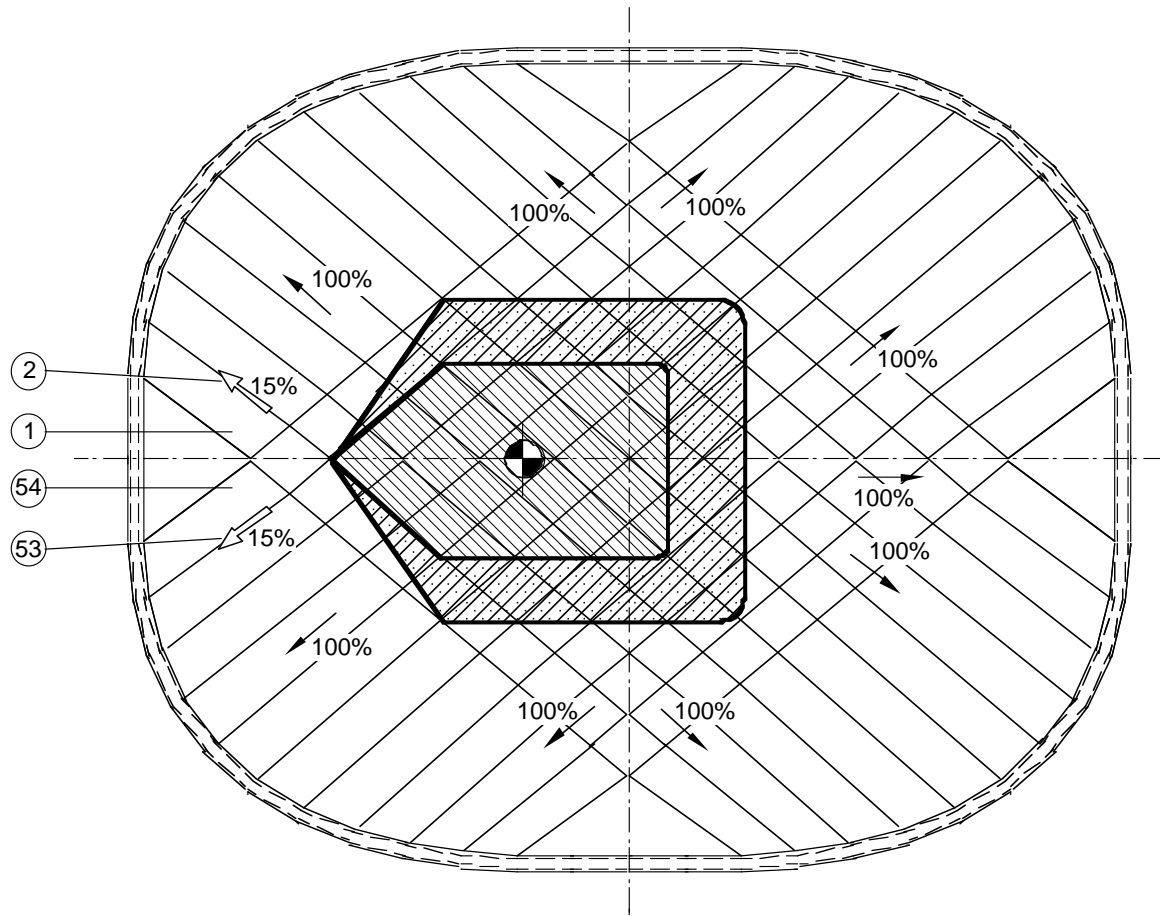
**Figure B1: Assumed Load Accumulation on Roof and Contribution to Failure**

The above plan shows the assumed drainage and collection of melt-water and rain on the roof. The manner in which load consolidated on the western center region of the roof through the morning of 5 January 2007 is illustrated. The approximate drainage away from the depressed portion of roof versus the retained load that that would become part of cascade towards triangle panel is shown.

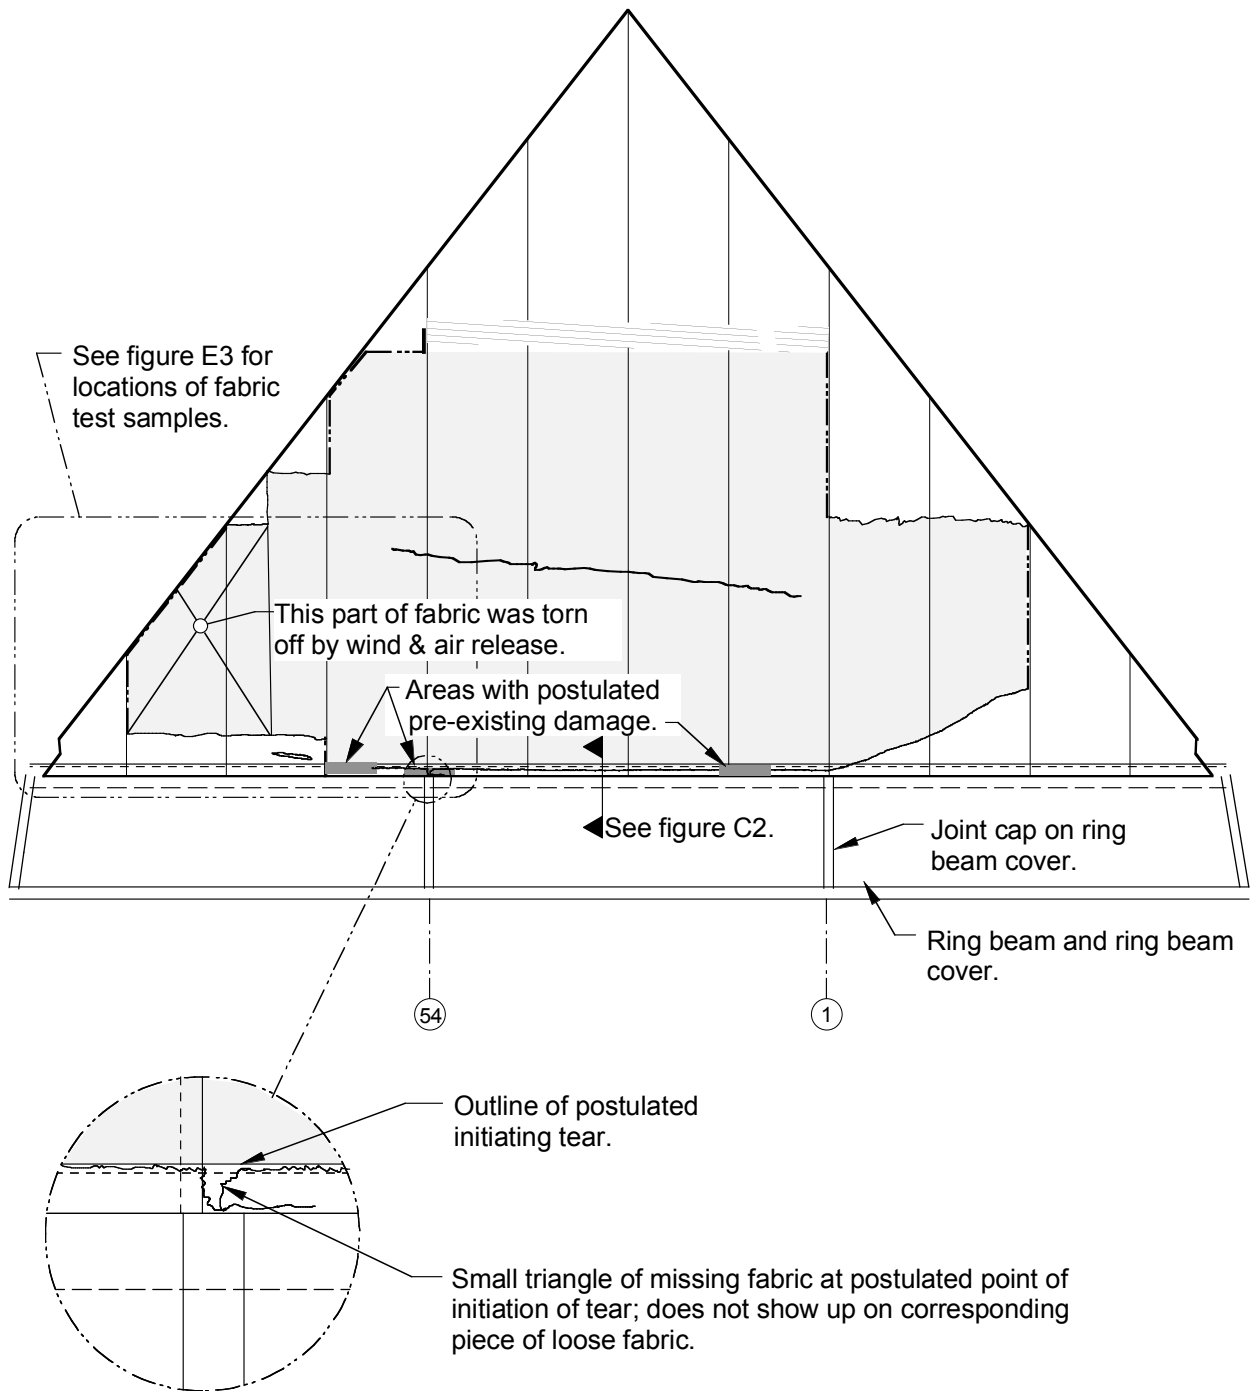
**Figure E1: Plan Of Damaged Triangle Panel**

2. The west triangle panel was substantially destroyed in the deflation incident and by the windstorms of the evening of the 5<sup>th</sup>. Appendix E figure E1 shows the locations of the tears and other observed damage to the triangle panel where the initial roof deflation hole developed. See Appendix A, Figures A1-2, A2-1, A2-2 for photos of the condition of the triangle panel on 6 January.

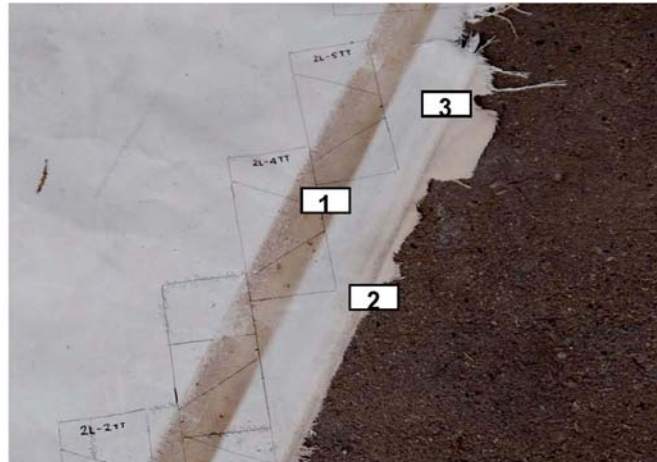
Figure E4-1: Samples 2L-TT

- 1 Darker discolored strip is field heat seal for the post-installed fabric flashing, which has pulled away.
- 2 Lighter discolored area was under edge clamp. Short fibers and irregular tear indicate weakened glass yarn
- 3 Distorted edge of a clamping bolt hole

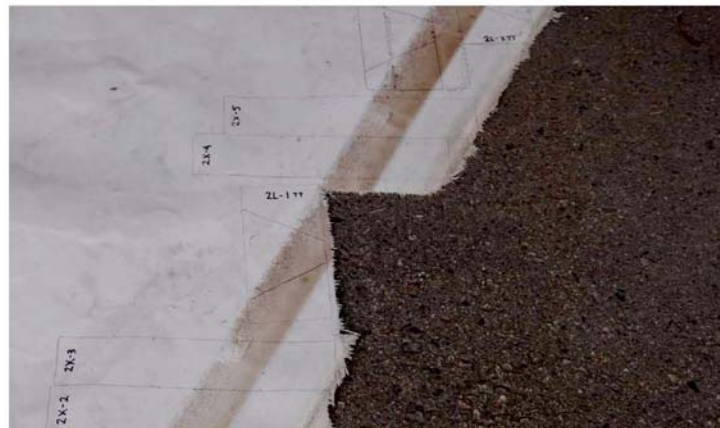
Figure E4-2: Samples 2X, 2L-TT Triangular notch does not correlate with anything on adjacent fabric segment. This was possibly removed by a souvenir hunter prior to recovery by BC Place staff.

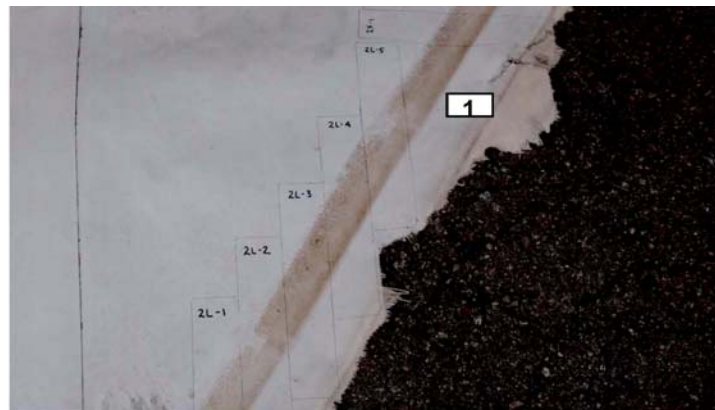
Figure E4-3: Samples 2L, 2X

- 1 Edge of bolt hole at fabric clamp; failure varies from behind clamp at roped edge to front edge of clamp.

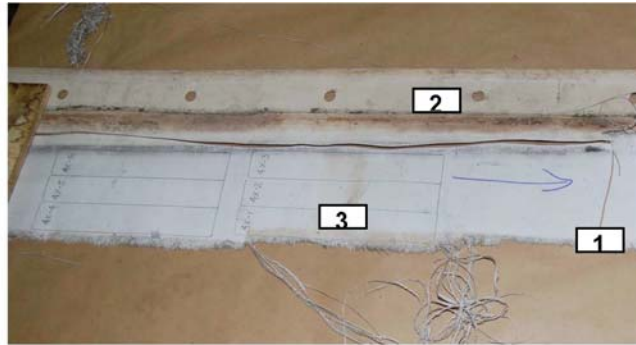
Figure E5-1: Samples 4X

Samples taken between tear at lower edge and ring beam.

- 1 – Shows irregular edge with short, clean yarn. The tear is at the bottom edge of the field weld.
- 2 – Knife cut made in field to remove fabric for sampling; this is not a tear.
- 3 – The edge is discolored at several points, and the corresponding yarns are short.

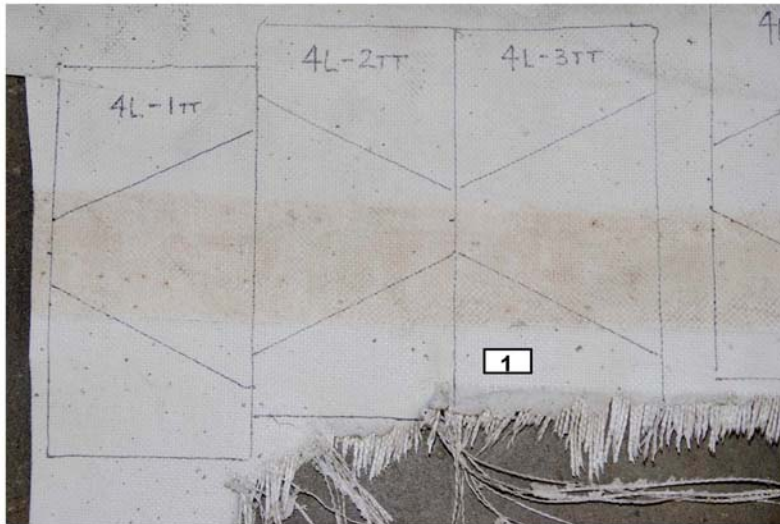
Figure E5-2: 4L-TT

Sample is taken from just above the tear along the ring beam.

- 1 – Note the slight discoloration of yarns at the edge.

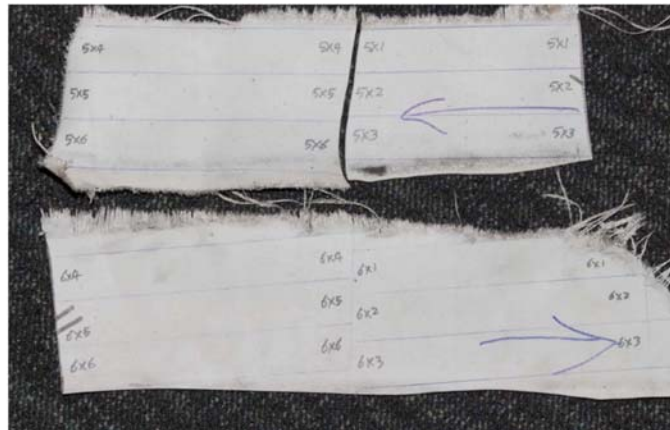
Figure E5-3: Samples 5X, 6X Samples taken from just above the tear.
