Author <i>Auteur</i>	Release date <i>Date émission</i>	Doc. no. <i>No. de doc.</i>	 
SLC/GSM	12-31-2006	SA-06-022

SAFETY ALERT BULLETIN / BULLETIN DE SÉCURITÉ

Lift manufacturer / <i>Fabricant</i> :	THIOKOL, STADELI, HALL, VON ROLL, CTEC, GARAVENTA CTEC, DOPPELMAYR, DOPPELMAYR CTEC	Fab. Group / <i>Groupe de fabrication</i> :	025 – TOWERS
Lift type / <i>Type de remontée</i> :	CHAIRLIFT	Effective date / <i>Date en vigueur</i> :	December 31, 2006
Supersedes / <i>Remplace</i> :	N/A

Title / Titre : **Tower failure due to water intrusion**

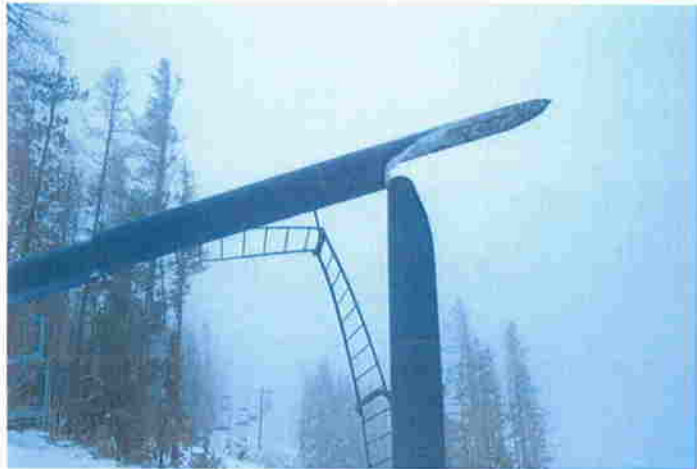
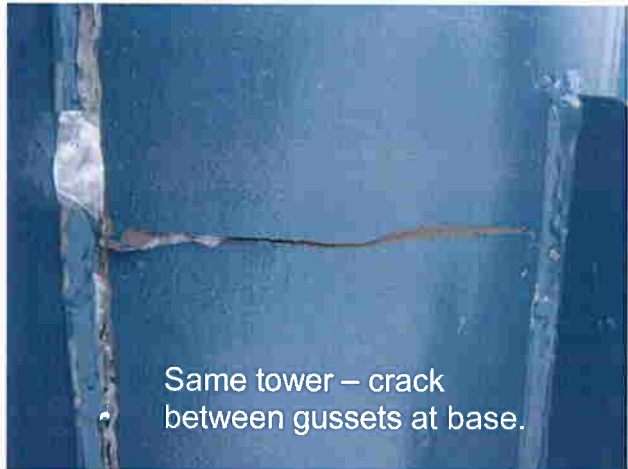
Recently, accumulated water within a tower tube froze and resulted in a complete failure of the tower tube. The failure occurred on a closed, unloaded lift at night after daily operations were complete.

The affected tower design had an open center splice ring connecting a larger diameter lower tube to a smaller diameter upper tube. The design of the splice ring had connecting bolts passing through the upper ring and threading into the lower ring. The threaded holes for the connecting bolts in the lower ring were inside the lower tube diameter. Typical assembly instructions for this type splice connections call for the use of mastic or caulking to inhibit water intrusion.

Tower: 6S/4S; 46' tall; 30' of 20" tube spliced to 16' of 16" tube. Ice filled to 30' position.

Weather conditions at failure:
Night; ~-5° F.; Wind ~ 57 mph.

Tower split vertically from base then hinged at approx. 18-1/2' and fell toward heavy side (uphill) line in the direction of prevailing wind.

Haul rope was trapped on both HS & LS assemblies.

Routine annual maintenance activities must include a close visual inspection of all tower components including the tower base. Signs of fatigue due to freeze / thaw cycles or cyclic loading may present themselves as indications (cracks) during the early stages, therefore, all welds,

gussets and tower tubes should be subject to close visual inspection annually. Any suspected indication noted visually should be confirmed by magnetic particle examination. The presence of any confirmed indication must be reported to Doppelmayr CTEC Engineering Department for review and recommended repair procedures.

Signs of weeping may indicate the presence of additional water within a tower. When struck with a dead-blow hammer in several ascending points from the base, a change in the resonating tone of the tower may indicate the presence of water (a tower with water tends to exhibit a solid “dead” sound compared to a more normal bell-like tone). Some tone differences may be noted due to proximity to base gussets and will not necessarily indicate the presence of water. Care should be taken to eliminate or minimize any obvious source of water intrusion.

- If water is suspected to be present, a small hole ($\frac{3}{8}$ " ~ $\frac{1}{2}$ ") may be drilled near the tower base at the side of the tower (90° to the haul rope) to provide a pathway for water to escape. This is a recommended action only where the presence of water is suspected. Holes should not be installed purely as a preventative measure or in lieu of annual inspection. Periodic cleaning of drain holes may be required to maintain their functionality.

If tower base inspections have not routinely been included and documented in annual maintenance activities, a visual inspection of each tower base for signs of fatigue must be completed within the next 30 days. Any suspected indication noted visually should be confirmed by magnetic particle examination. The presence of any confirmed indication must be reported to Doppelmayr CTEC Engineering Department for review and recommended repair procedures.

Any confirmed indication greater than 1 inch (25 mm) in length shall be cause for immediate and continued closure of the lift to public transportation until repairs are authorized by Doppelmayr CTEC and implemented.

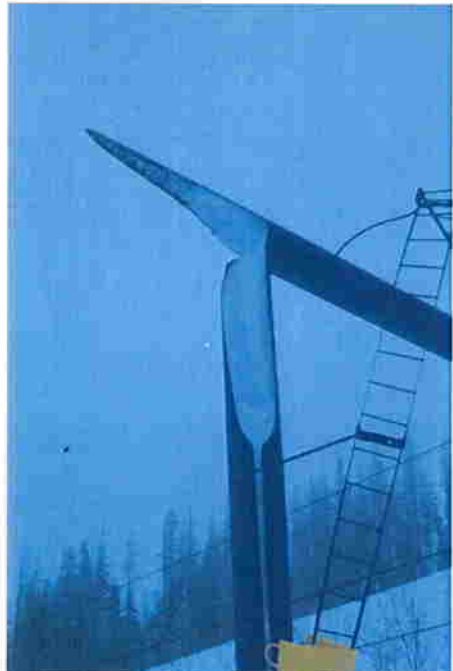
Horizontal tower base crack 10-1/2" long, 14" up from base.
