Independent Power Producer (IPP) Inspection Project Report

Stave Lake and Lamont Hydroelectric Projects

Project: Stave and Lamont hydroelectric projects

Date of inspection: October 8, 2008

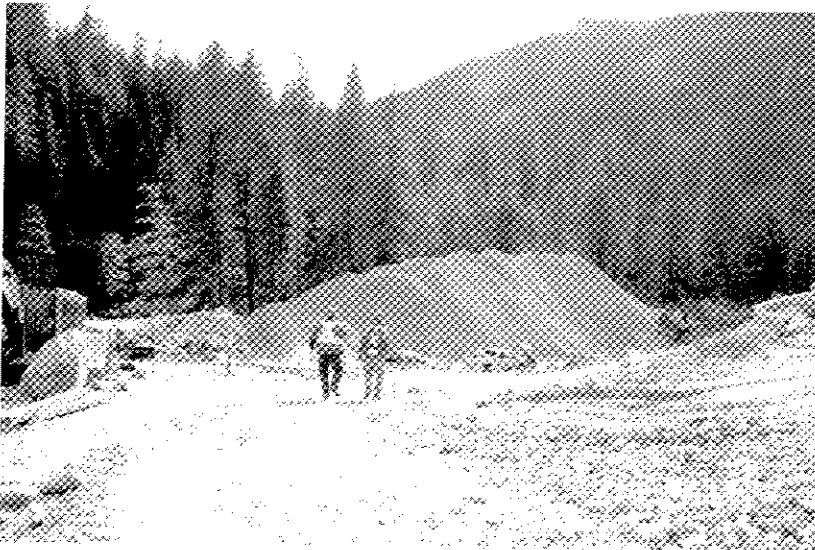
3.1 Stave: Sediment control structures were not installed down-slope of large pile of crushed rock adjacent to stream (~20 m), contrary to BMPs and the CEMP. Justification given for this was the lack of organic material contained in the pile, and the placement of large rocks at the base for stabilization. (Figure 1; Malt)

Figure 1. Construction at Stave intake site. Note pile of crushed rock in background (Stave river is ~ 20 m from the pile on the opposite side).

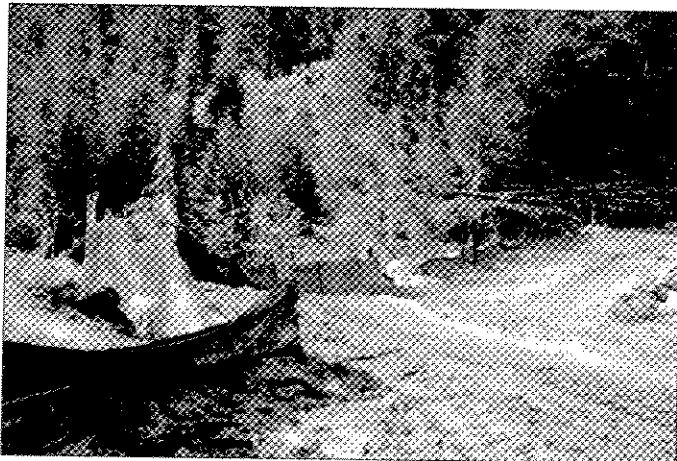
3.2 Lamont: There was over-reliance on silt fencing for erosion control along the Lamont access road. Single row silt fencing should not be the only technique used for erosion control. MOE recommends the use of other techniques to provide additional lines of erosion control (such as depth). The access road and the erosion control works require a shut-down plan for stabilizing the works for winter and spring runoff conditions. (Figure 2; Davies)

Figure 2. Silt fencing along Lamont access road.

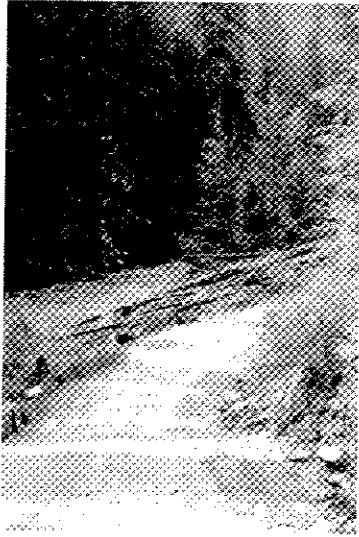
3.3 Lamont: Wood and spoil from Lamont ROW clearing was decked on downstream side of road. Mac Lowry has already brought this to the attention of the contractors to be changed, and avoided in the future (Figure 3; Malt).

Figure 3. Wood decked on stream-side of river along Lamont access road.

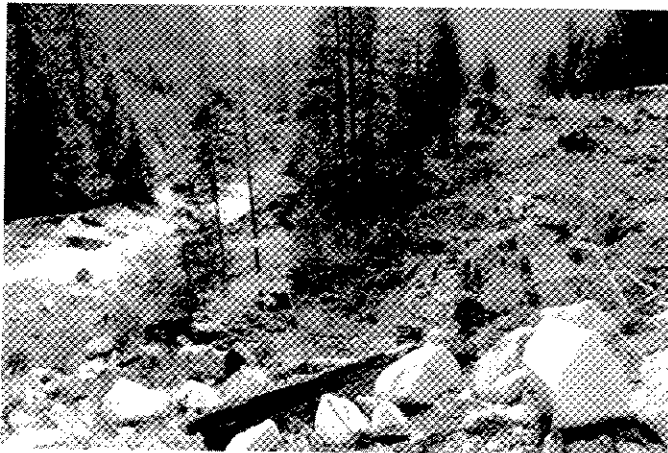
5.1 Lamont: Clearing of Lamont penstock/road ROW occurred immediately adjacent to the river. The Forest and Range Practices Act (FRPA) does not apply in this case because the Occupant Licence to Cut (OLTC) is exempt from Section 51 and 52 (restrictions in riparian reserve and management zones respectively) of the Forest Planning Practices Regulation (FPPR) (Feldes). However, MOE strongly discourages cutting this close to the river, as riparian areas provide high quality habitat for many wildlife and plant species, including species at risk (Figure 4; Malt).

Figure 4. Clearing of Lamont penstock ROW immediately adjacent to the river.

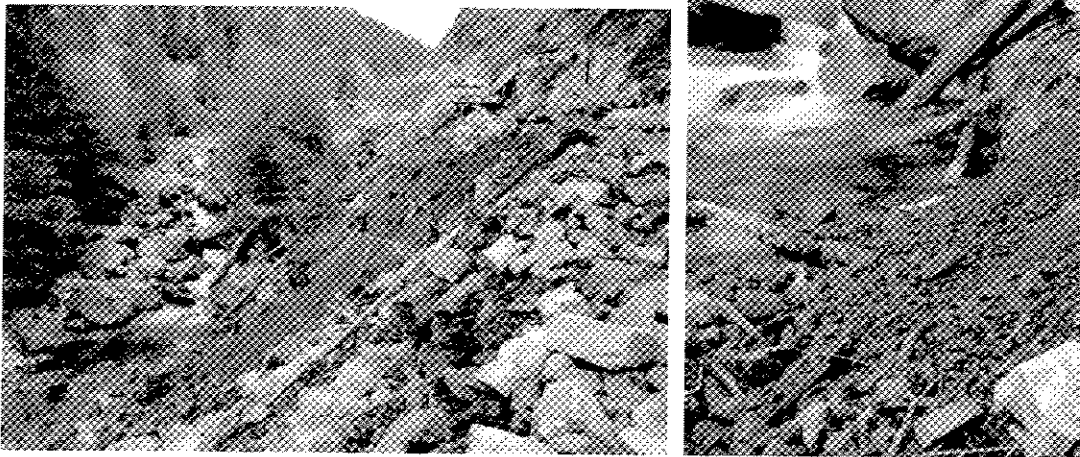
1.1 Stokke: A small slide or side cast of material was observed along the Stokke access road built under the Conditional Water License (~ station 0 + 550m). Rock and soil material had slid down the bank to the edge of Stokke Creek. Given that heavy rains were forecasted for the evening of October 8, there was a high risk of sediment entry into Stokke Creek, which would constitute a violation under the Water Act. Moreover, sediment control structures were not installed down-slope of road building at this location, contrary to commitments under the CEMP. Kiewit/Cloudworks personnel were instructed to promptly mitigate this issue at the debriefing session. The EM confirmed to J.Malt (MOE) that the slide was covered on the afternoon of October 8 to prevent entry of sediment into Stokke Creek. MOE recommends that measures be taken by Cloudworks and Kiewit to prevent similar issues from occurring in the future. (Figure 1 ; Malt, Feldes)

Figure 1. Slide during construction of Stokke access road (left). Material reached edge of Stokke Creek (right).

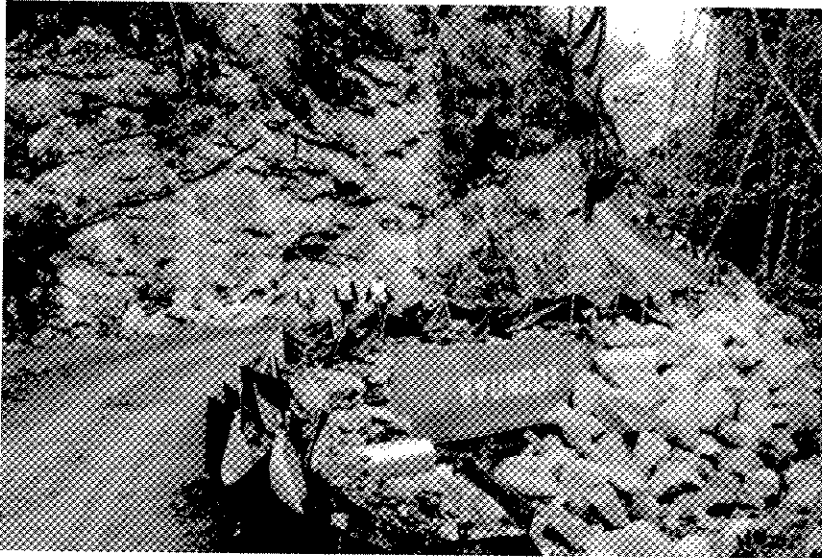
1.2 Stokke: MOE is concerned regarding a shipping container used to stabilize the road at the narrowest portion of the Stokke Creek canyon (the "pinch point"). Mike Hedberg stated that the container was a temporary measure that will be removed once the penstock and road construction is completed. According to the EM, a Leave to Construct had not yet been given for construction at the pinch point, although leaves had been granted for other portions of the penstock and access road. MOE recommends that road/penstock construction should not be initiated until all leaves have been granted, as non-approved temporary works such as the shipping container may be unstable and could result in environmental impacts. (Figure 2; Malt)

Figure 2. Shipping container used to stabilize the road at the “pinch point” of the Stokke access road.

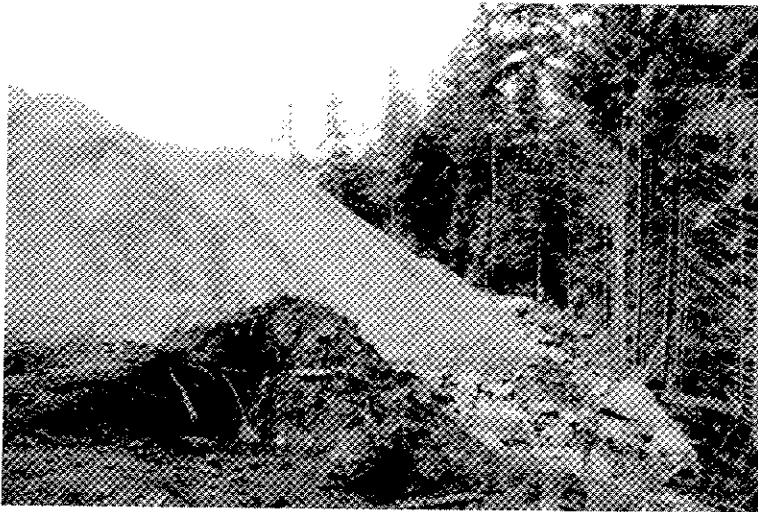
1.3 Stokke: A large pile of crushed rock set aside for penstock bedding material had no berm surrounding it to prevent slipping into adjacent forested areas. MOE recommends that a berm be built in this location to prevent slippage. This is particularly important on the stream side, where slippage could cause damage to riparian and instream areas. (Figure 3; Malt)

Figure 3. Crushed rock lacking berm, adjacent to the Stokke access road.

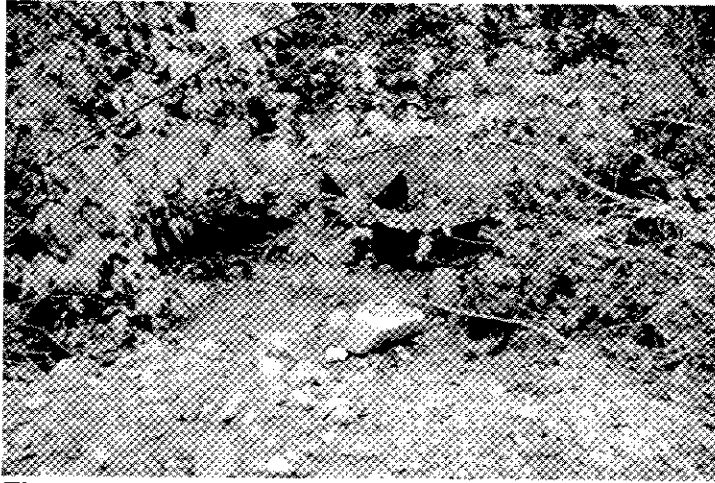
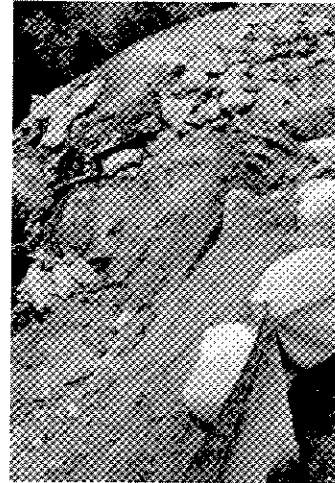
1.4 Tipella: Large amounts of sediment were observed at the discharge point of a culvert along the Tipella access road. The bank surrounding the culvert was not properly armoured, leading to collapse and high amounts of build-up behind the sediment fences. MOE recommended that the bank be properly stabilized, and the sediment build-up be removed to limit discharge into the forest. (Figure 4; Malt)

Figure 4. Sediment build-up below culvert along the Tipella access road (left), and collapse of bank adjacent to culvert (right).

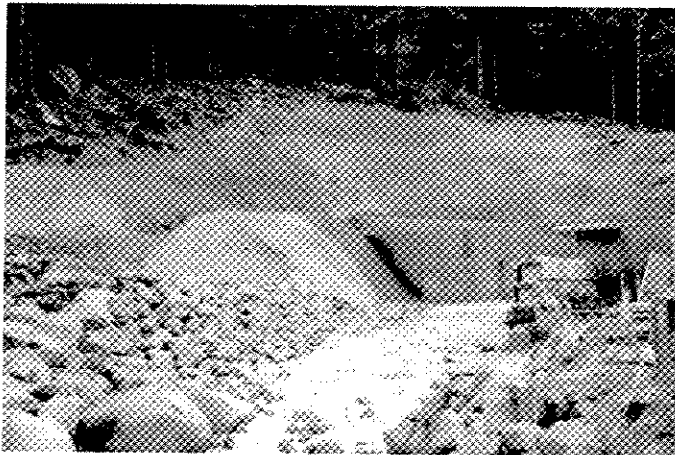
2.1 Tipella: Revegetation of the penstock ROW at Tipella was done with a 'non-invasive' seed mix, which includes non-native species, contrary to BMPs and the CEMP. Red Alder has been added as a native component in areas where the roots won't cause damage to the penstock. MOE recommends sourcing of an all-native seed mix to meet commitments under the CEMP. (Figure 5; Malt)

Figure 5. Revegetation above construction of the Tipella intake.

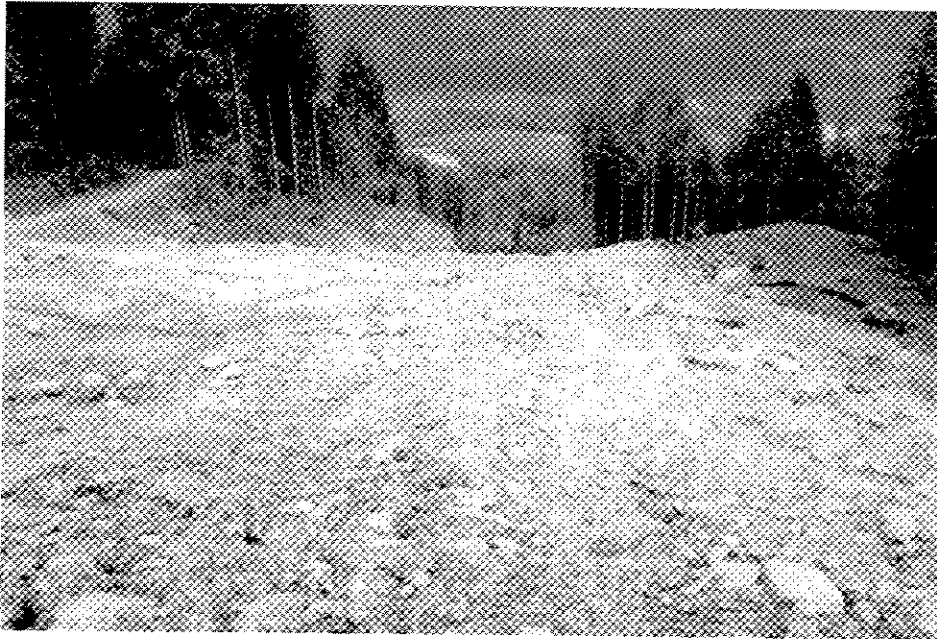
2.2 Tipella: Clearing of ROWs was not limited to 15 m in old-growth forest and 30 m otherwise, as committed to in the CEMP. Clearing for the access road and penstock ROW was wider than necessary, particularly in spoil areas. For instance, clearing above the Tipella powerhouse (immediately above the steep section) was particularly wide (i.e. ~ 100m) because the alignments had been changed post-clearing (according to Hedberg). MOE recommends that clearing of ROWs be limited to the narrowest widths possible, and that respective commitments in the CEMP should be followed. (Figure 6; Malt)

Figure 6. Penstock and access road clearing at Tipella.

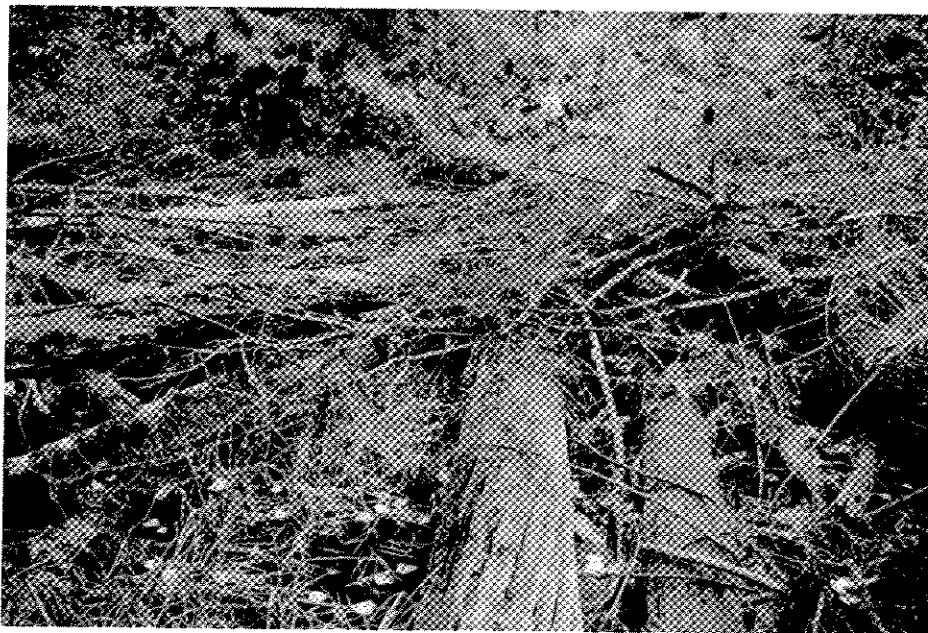
3.1 Tipella: A small wetland was observed adjacent to recent transmission line clearing adjacent to the Tipella access road (~1 km marker). Although this wetland has been impacted by previous logging activities, it is still likely to be a viable site for amphibian breeding. The EM is aware of this site and will monitor it to help prevent any damage from future transmission line construction or other activities. MOE recommends

Figure 7. Small wetland adjacent to Tipella transmission line clearing (damage is from previous forestry activities).

this site as a potential location for habitat restoration as a stewardship/outreach activity for Cloudworks. (Figure 7; Malt)
