# COLLISION INVESTIGATIONS

SPECIAL INVESTIGATION V

ASF5-1210

1997 Ford E 350 Super Club XLT Van

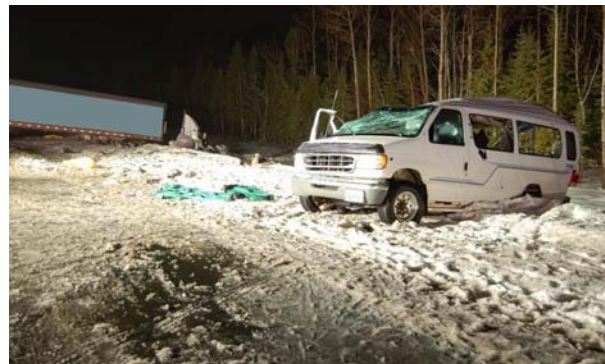
The E350 was rotating clockwise as it travelled to the northwest after impact. The E350 came to rest facing east on the shoulder / roadway embankment adjacent to the southbound lane of the highway.

**Figure 1: E350 & tractor-semi-trailer at FRP**

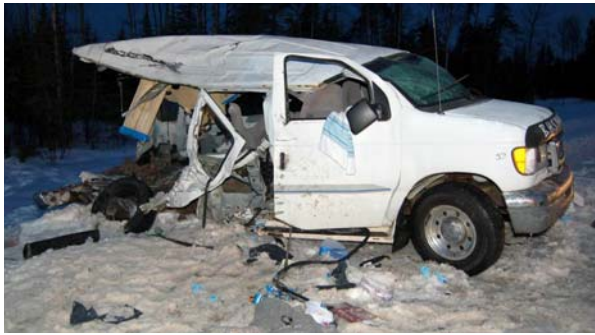
**Figure 2: Right side of E350 at FRP**

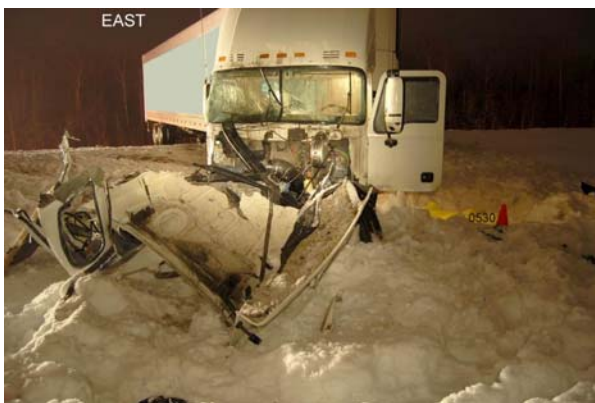
The tractor semitrailer travelled to the southwest onto the shoulder of the southbound lane after impact. The tractor came to rest facing west and was furrowed in the snow on the roadway embankment, approximately 40 metres from the point of impact. The semitrailer was intact and had remained connected to the tractor after the crash. The semitrailer was facing southwest, with the rear of the unit resting diagonally across the southbound lane and encroaching into the northbound lane. Wreckage from the rear and right side wall of the E350 was on the embankment near the right side of the tractor at final rest.

**Figure 3: Front of tractor-semitrailer at FRP**

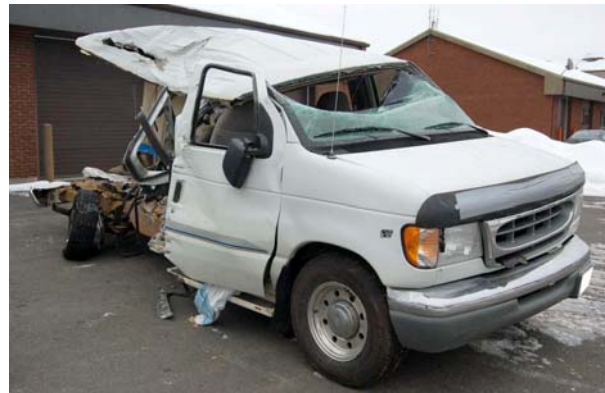
The tractor unit initially contacted the right wall of the E350 just behind the B-pillar. The entire rear wall and the portion of the right wall that is rearward of the B-pillar were completely separated from the E350. The right front corner of the roof was displaced rearward and downward. The roof deformation severed the connection between the roof and the top of the right A-pillar. It also extensively cracked the entire windshield and tore the laminated windshield horizontally from the top of the right A-pillar to the top of the left A-pillar. All of the remaining window glazing was shattered, with the exception of the window in the driver's door and the left side cargo window. The mount for the passenger side mirror was broken. The right rear tire was punctured and deflated. The right rear wheel rim was broken and deformed. The bolts were sheared off that hold the front spring shackle for the right rear suspension to the vehicle frame. The right rear wheel assembly was displaced 16 cm rearward. The mount holding the spare tire failed, allowing it to separate from its storage location at the rear underside of the vehicle.

**Figure 4: Right front of E350**

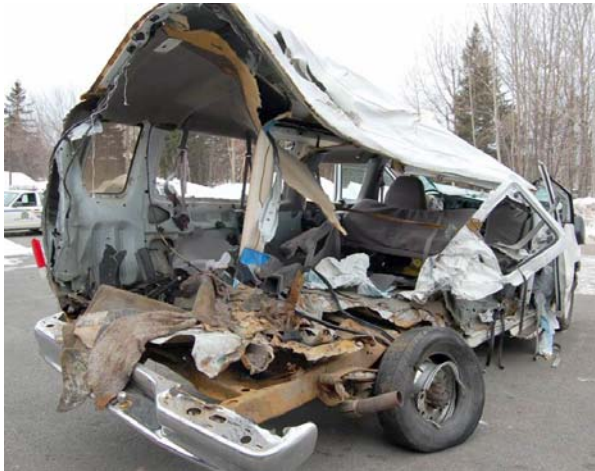
The front of the tractor penetrated approximately 110 cm into the right side of the E350, intruding the right wall and rear right side doors of the E350 into the occupant compartment just before they were torn from the vehicle. The front passenger seatback

**Figure 5: Right rear of E350**

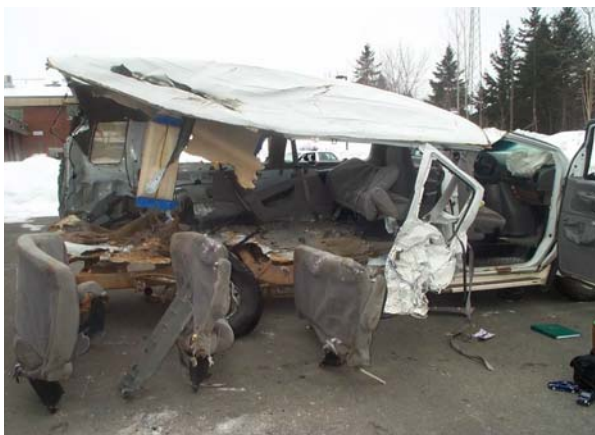
was twisted clockwise from loading by occupant 0230. A detachable seatbelt anchor assembly, used to attach the lower portion of the seatbelt webbing to the right side of seat 0230, was contacted by the intruding right side wall. This contact damaged the buckle and released the latchplate for the anchor. The seatback for the floor mounted bench seats in row two was deformed forward by occupant loading. The last three rows of seats, also floor mounted bench type seating, were broken from the floor by intrusion. The last three rows of seats were ejected out of the vehicle during the crash.

**Figure 6: Right side of E350 with ejected seats**

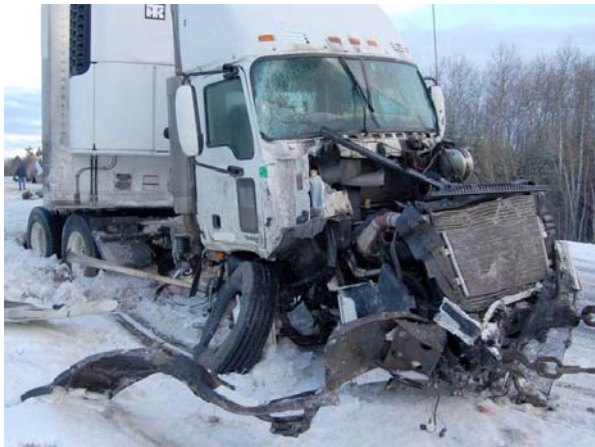
The front-end of the tractor was crushed rearward, involving the front bumper, the hood, and the right and left front fender. A maximum crush of 27 cm rearward was measured to the left of the centre of the front bumper beam, corresponding to the point of impact with the right rear wheel assembly of the E350. The bumper fascia was almost completely separated from the tractor. The left side of the steering axle was displaced 16 cm rearward. The right side of the steering axle was displaced approximately 66 cm rearward. The front of the right side diesel tank was crushed rearward from contact with the displaced right front wheel. The damaged fuel tank broke from its mounts and completely separated from the vehicle during the

crash. The fiberglass engine cowl and fender assembly was shattered, with the damage concentrated on the right side of the assembly. The radiator core was crushed and punctured. The windshield was extensively cracked from the contact with vehicle debris. The cab was twisted clockwise on the vehicle frame. A TDC of 12FZEW6 was determined for the tractor's impact with the E350.

**Figure 7: Right front of Tractor with attached semitrailer**

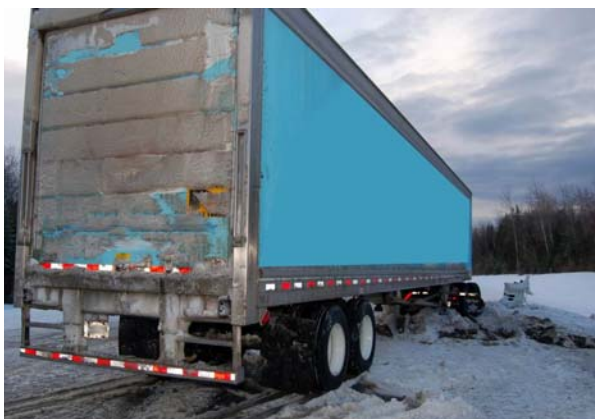
The semitrailer was undamaged during the collision.

**Figure 8: Right rear semitrailer**
