Transport  
Canada  
Road Safety

# COLLISION INVESTIGATIONS

SPECIAL INVESTIGATION V

ASF5-1210

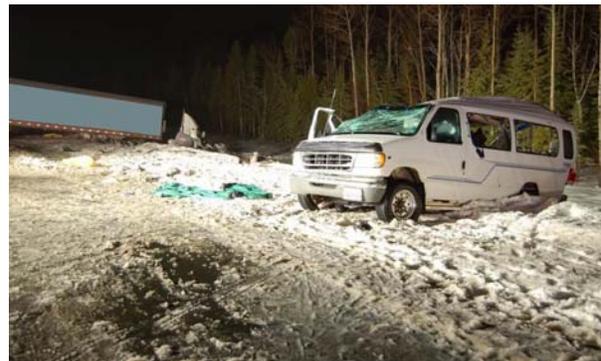
The E350 was rotating clockwise as it travelled to the northwest after impact. The E350 came to rest facing east on the shoulder / roadway embankment adjacent to the southbound lane of the highway.

**Figure 1: E350 & tractor-semi-trailer at FRP**

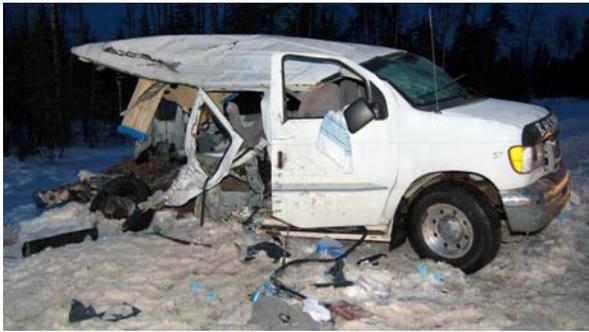
**Figure 2: Right side of E350 at FRP**

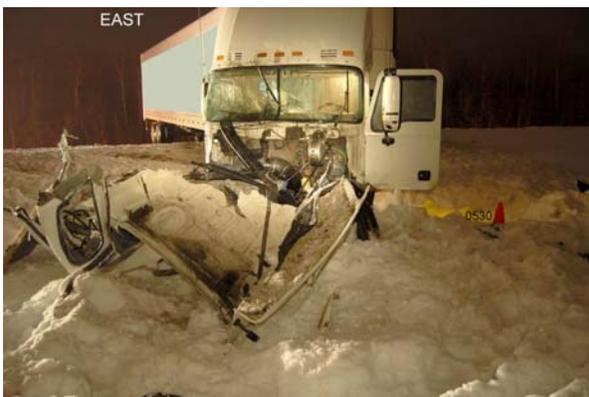
The tractor semitrailer travelled to the southwest onto the shoulder of the southbound lane after impact. The tractor came to rest facing west and was furrowed in the snow on the roadway embankment, approximately 40 metres from the point of impact. The semitrailer was intact and had remained connected to the tractor after the crash. The semitrailer was facing southwest, with the rear of the unit resting diagonally across the southbound lane and encroaching into the northbound lane. Wreckage from the rear and right side wall of the E350 was on the embankment near the right side of the tractor at final rest.

**Figure 3: Front of tractor-semitrailer at FRP**

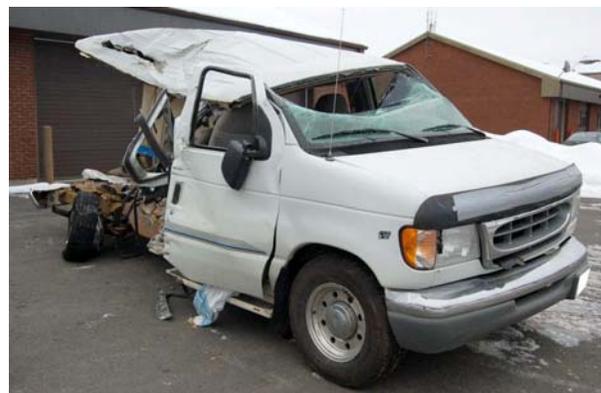
The tractor unit initially contacted the right wall of the E350 just behind the B-pillar. The entire rear wall and the portion of the right wall that is rearward of the B-pillar were completely separated from the E350. The right front corner of the roof was displaced rearward and downward. The roof deformation severed the connection between the roof and the top of the right A-pillar. It also extensively cracked the entire windshield and tore the laminated windshield horizontally from the top of the right A-pillar to the top of the left A-pillar. All of the remaining window glazing was shattered, with the exception of the window in the driver's door and the left side cargo window. The mount for the passenger side mirror was broken. The right rear tire was punctured and deflated. The right rear wheel rim was broken and deformed. The bolts were sheared off that hold the front spring shackle for the right rear suspension to the vehicle frame. The right rear wheel assembly was displaced 16 cm rearward. The mount holding the spare tire failed, allowing it to separate from its storage location at the rear underside of the vehicle.

**Figure 4: Right front of E350**

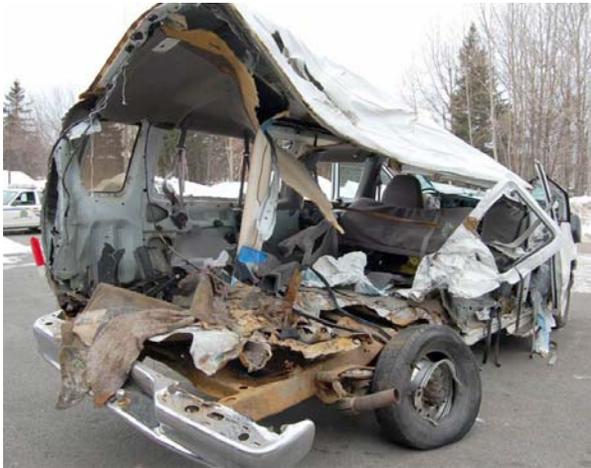
The front of the tractor penetrated approximately 110 cm into the right side of the E350, intruding the right wall and rear right side doors of the E350 into the occupant compartment just before they were torn from the vehicle. The front passenger seatback

was twisted clockwise from loading by occupant 0230. A detachable seatbelt anchor assembly, used to attach the lower portion of the seatbelt webbing to the right side of seat 0230, was contacted by the intruding right side wall. This contact damaged the buckle and released the latchplate for the anchor. The seatback for the floor mounted bench seats in row two was deformed forward by occupant loading. The last three rows of seats, also floor mounted bench type seating, were broken from the floor by intrusion. The last three rows of seats were ejected out of the vehicle during the crash.

**Figure 5: Right rear of E350**

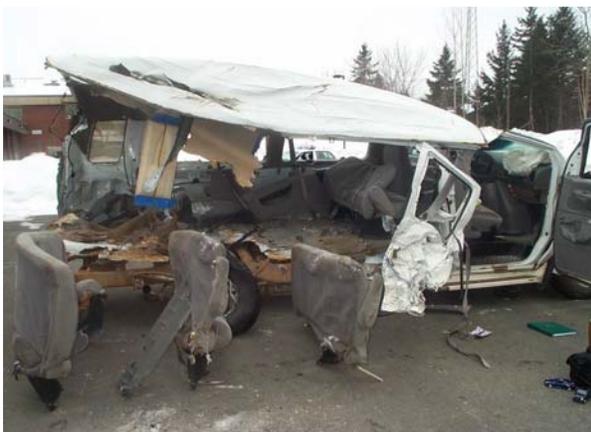
**Figure 6: Right side of E350 with ejected seats**

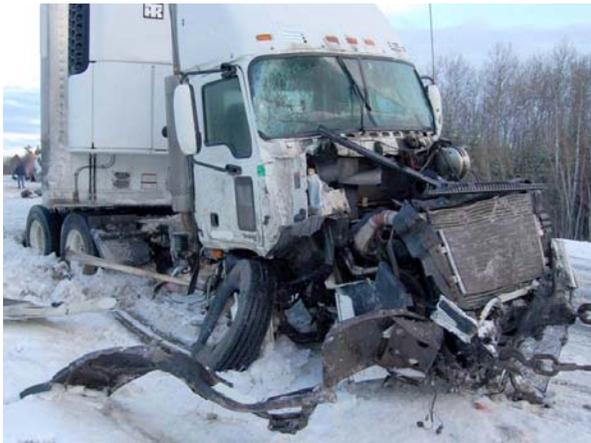
The front-end of the tractor was crushed rearward, involving the front bumper, the hood, and the right and left front fender. A maximum crush of 27 cm rearward was measured to the left of the centre of the front bumper beam, corresponding to the point of impact with the right rear wheel assembly of the E350. The bumper fascia was almost completely separated from the tractor. The left side of the steering axle was displaced 16 cm rearward. The right side of the steering axle was displaced approximately 66 cm rearward. The front of the right side diesel tank was crushed rearward from contact with the displaced right front wheel. The damaged fuel tank broke from its mounts and completely separated from the vehicle during the

crash. The fiberglass engine cowl and fender assembly was shattered, with the damage concentrated on the right side of the assembly. The radiator core was crushed and punctured. The windshield was extensively cracked from the contact with vehicle debris. The cab was twisted clockwise on the vehicle frame. A TDC of 12FZEW6 was determined for the tractor's impact with the E350.

**Figure 7: Right front of Tractor with attached semitrailer**

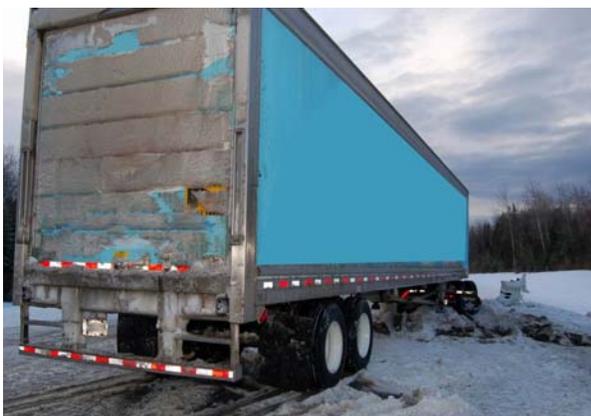
The semitrailer was undamaged during the collision.

**Figure 8: Right rear semitrailer**
