## BC PLACE STADIUM

# ROOF DEFLATION INCIDENT INVESTIGATION ENGINEER'S REPORT

12 October 2007

By: **Geiger Engineers**  
Bellingham, WA  
**Kris P. Hamilton P.E.**  
David M. Campbell P.Eng.

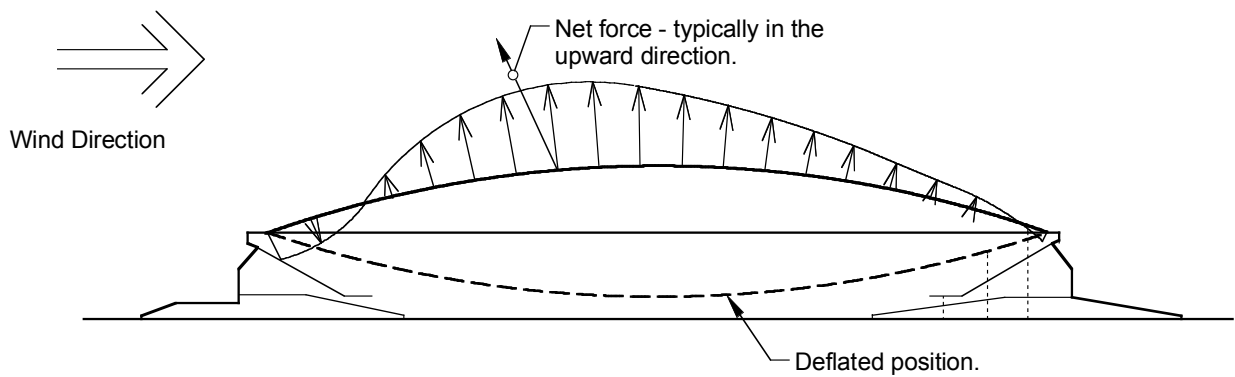
Figure D1-2: Wind Forces on a Low Profile Air-Supported Roof

Figure D1-2 shows how the wind pressures vary over the surface of the roof. The arrows show the direction of the wind force on the roof; note that in most conditions, the wind tends to lift the roof up. Thus, the force on the roof due to wind tends to add to the forces on the roof due to internal pressure, and the roof therefore must be designed for a condition of maximum wind uplift pressure plus the maximum possible internal pressure.

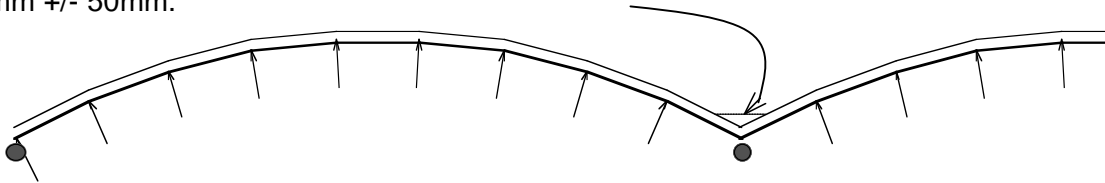
A mixture of snow, water and ice collects in the valleys between panels; for calculation purposes assume that the valley is blocked with snow & slush at the next intersecting valley, preventing drainage. The water depth accumulating into a valley from the panels each side is = 200mm +/- 50mm.

If one additional diamond panel valley drains into the same valley, the resulting depth will be 300mm +/- 50mm.

**SECOND STAGE:** Snow and rain continue to accumulate; pond starts to form.

For a typical fabric tension of 2 N/mm at 250 Pa interior pressure, and a uniform load equivalent to 50 mm of wet snow, a water depth of about 300mm +/- is necessary to initiate and maintain a pond.

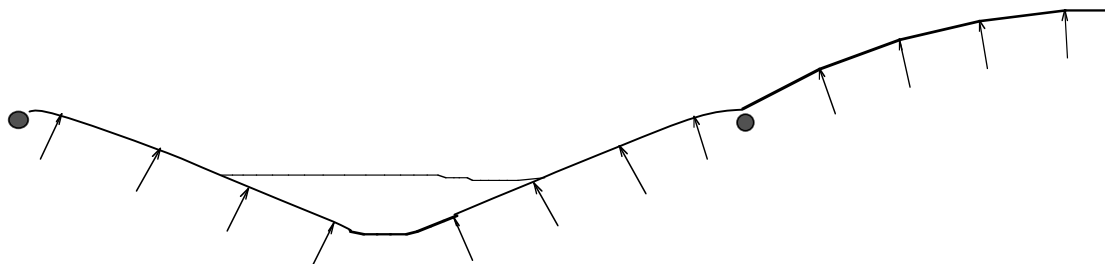
**THIRD STAGE:** Full pond develops.

Fabric still pulls up but total weight nearly exceeds the internal pressure. The total pressure over the area of a diamond panel is approximately 40 kN, which is equal to 4 cubic meters of water. This would be a pond about 2.7 m in diameter and 700mm deep.
